Assessment of The Magnitude and Spatial Pattern of Erosion in Central Part of Katsina State, Nigeria

Hamisu Ibrahim¹ and Aliyu Mohammed Aliyu²

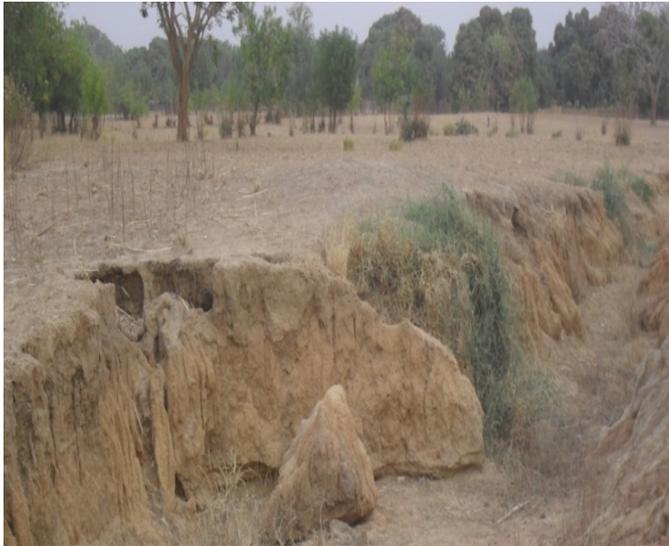
Figure 2: (S3) Moderate-Severity Gully Erosion at Kankia

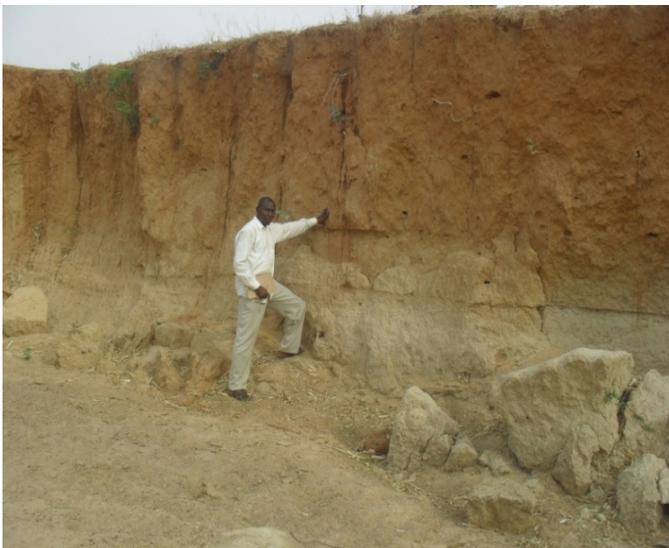
Figure 3: (S2) Severe Gully Erosion along at Dutsin-ma along Wakaji Road

Table 1 shows that among the gullies studied in the field, site S₂ at Dutsin-ma is the largest in size and in both mean depth and width. It appears to be a spectacular u-shaped gully with sides more or less like a cliff with a depth of up to 6 metres. This is a typical severe gully in the study area. The second largest is S₁₀ which has 68.6 meters cross sectional area and yet is the widest but very narrow in proportion to its width.
