Evaluating Ceramic and Porcelain Finishes as Cost-Effective Alternatives to Recurrent Painting in Public Buildings in Akwa Ibom State

Abstract— Public buildings in Akwa Ibom State, Nigeria, experience persistent challenges related to the durability and aesthetic performance of interior and exterior wall finishes. Architectural painting remains the dominant finishing method due to its low initial cost and ease of application; however, its vulnerability to humidity, environmental exposure, and surface wear necessitates frequent renewal. These repeated repainting cycles generate ongoing financial burdens and operational disruptions for public institutions. Globally, ceramic and porcelain tile finishes are recognized for their durability and resistance to moisture, yet their suitability and long-term economic viability within Nigeria's public-sector building context remain insufficiently explored. This study presents an interdisciplinary assessment of ceramic and porcelain finishes as alternatives to conventional paint systems, incorporating life-cycle cost analysis, material performance characteristics, maintenance requirements, and sustainability considerations. Drawing on empirical

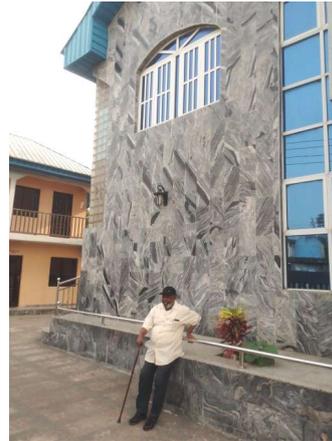
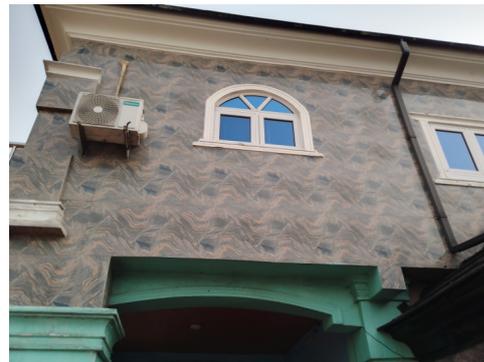
Figure 1 & 2: Church Building using marble-porcelain finishing
